**HOWARD COUNTY DEPARTMENT OF PUBLIC WORKS
CORROSION CONTROL TEST STATION
FIELD DATA SURVEY FORM**

Location: 00+00 Date Surveyed: 3/18/2005
Hammond Parkway Surveyed by: AC/MJ
 T/S #: 01 Contract #: 44-3868
 T/S Type: IJ w/ Anodes Pipe Size: 16"

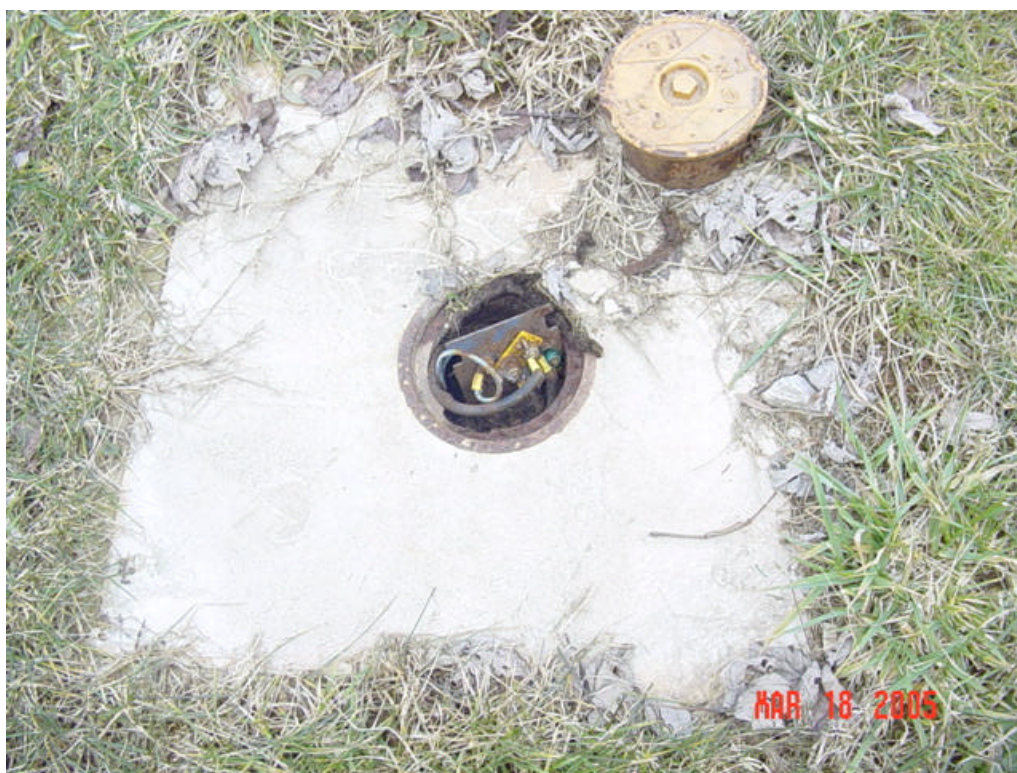
Figure 87 - Test Station 1 close up

Test Box : Good
 Terminal Board : Good
 Wires : #5 Broken
 Other : _____

Test Box: _____
 Terminal Board: _____
 Wires: _____
 Other: _____
 Additional Comments/Recommendations: #5 wire is unrepairable
