**HOWARD COUNTY DEPARTMENT OF PUBLIC WORKS  
CORROSION CONTROL TEST STATION  
FIELD DATA SURVEY FORM**

**Location:** Cedar Ave. & Georgia Ave. **Date Surveyed:** 3/22/2005  
**T/S #:** 03 **Surveyed by:** AC/MJ  
**T/S Type:** ST w/ Anode **Contract #:** 24-3811  
**Pipe Size:** 8"

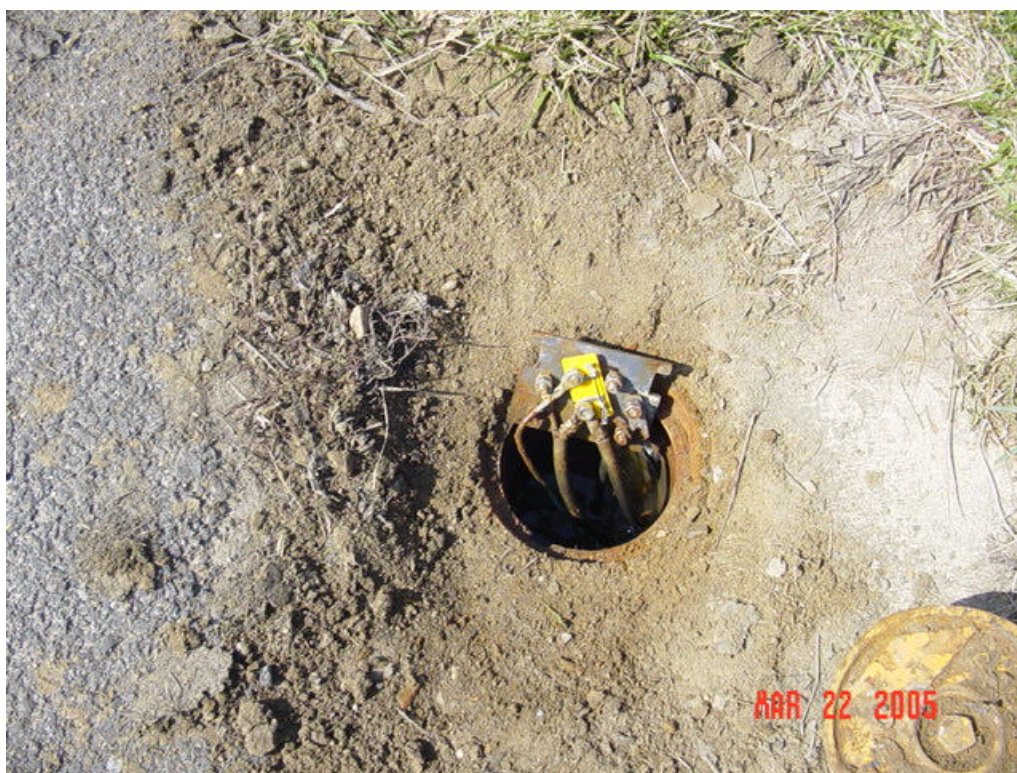
**Figure 202 - Test Station 3811-3 close-up**

**Test Box :** Covered by Soil and Filled with Water  
**Terminal Board :** Good  
**Wires :** Good  
**Other :** \_\_\_\_\_
