Table 4- MD Route 108 Test Station 4

HOWARD COUNTY DEPARTMENT OF PUBLIC WORKS CORROSION CONTROL TEST STATION FIELD DATA SURVEY FORM						
Location:	<u>(114+50)</u>	Date Surveyed:	<u>3/13/2006</u>			
T/S #:	<u>4</u>	Surveyed by:	<u>MJ/AC</u>			
T/S Type:	<u>ST/A</u>	Contract #:	<u>44-3218</u>			
		Pipe Size:	<u>16"</u>			
Was Test Station located? YES/NO <u>YES</u>						
TEST STATION CONDITION						
Test Box :	<u>Above ground PVC - good</u>					
Terminal Board :	<u>5 terminal - good</u>					
Wires :	<u>good</u>					
Other :	_____					
SURVEY DATA						
Test Wire Size/Description	Color	P/Cu-CuSO ₄ (V)		P/Zn (V)		Anode (mA)
		"On"	"Off"	"On"	"Off"

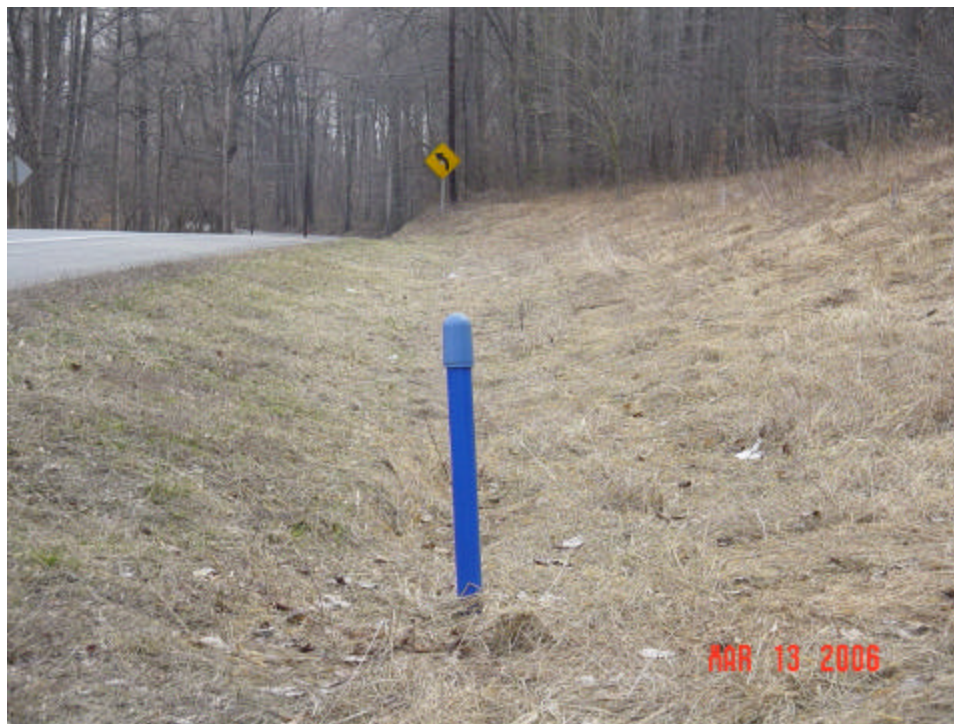
Figure 9 – Test Station 4

A) #10 Pipe	Black	-0.809	-0.530			1.7
B) #8 Pipe	Black	-0.808	-1.785			
C) #12 Pipe	Black	-0.807	-0.526			
D) #10 Pipe	Black	-0.807	-0.527			
E) #12 Pipe	Black	-0.807	-0.526
