**HOWARD COUNTY DEPARTMENT OF PUBLIC WORKS  
CORROSION CONTROL TEST STATION  
FIELD DATA SURVEY FORM**

Location: 5' S. of MD 108/ MD 32 Bridge Date Surveyed: 05/30/2007  
 T/S #: 01 Surveyed by: AS/MJ  
 T/S Type: IJ Contract #: 44-3231  
 Pipe Size: 12"  
 Was the T/S located? YES / NO YES

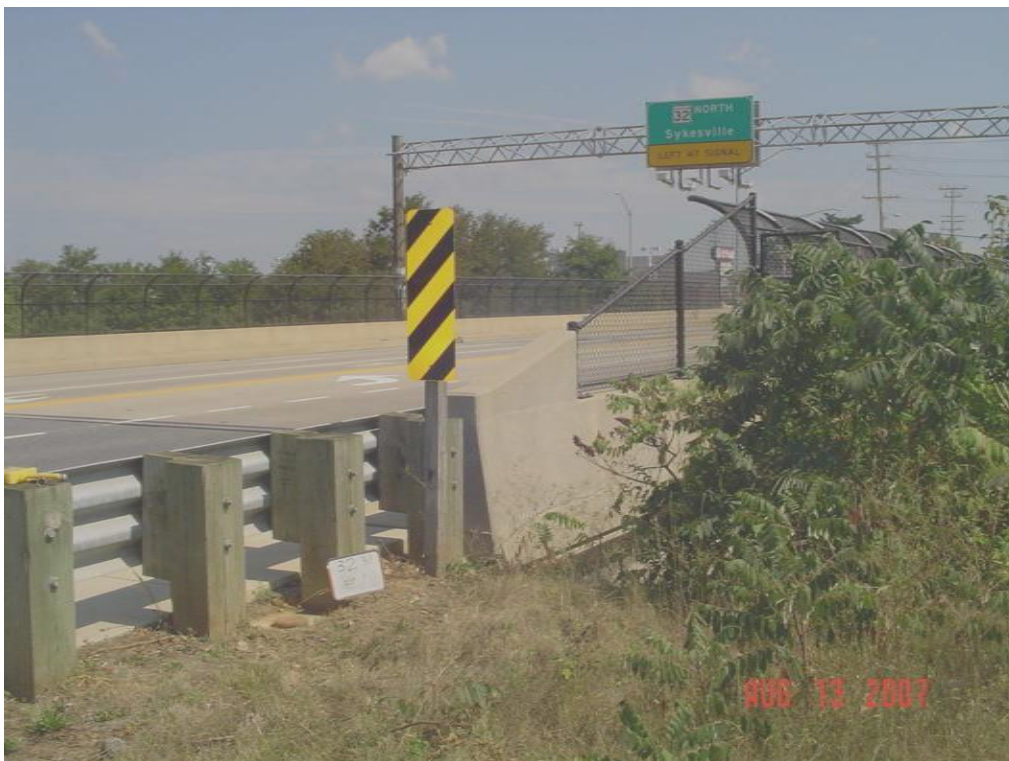
Figure 103 - Location of Test Station 3231-1

Test Box:	Good
Terminal Board:	Good
Wires:	Good
Other:

Test Box:	_____
Terminal Board:	_____
Wires:	_____
Other:	_____
Comments/Recommendations:	<u>IJ test indicated effective isolation of the two pipes.</u>
