HOWARD COUNTY DEPARTMENT OF PUBLIC WORKS CORROSION CONTROL TEST STATION FIELD DATA SURVEY FORM

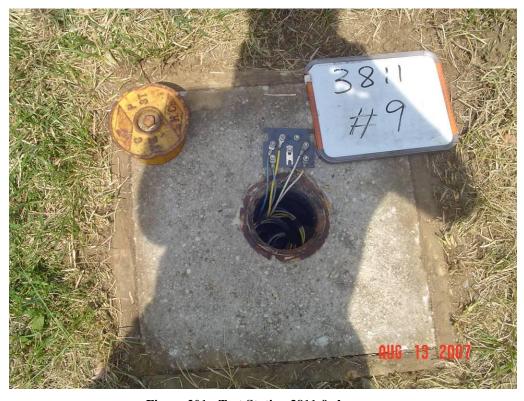
Figure 201 - Test Station 3811-9 close-up

AIAGGRVEITG				
Location:	Cedar Ave. and Donald Ave.			Date Surveyed		06/14/2007		
T/0 "				Surveyed by:		AS/MJ		
T/S #: 09			Contract #:			24-3811		
T/S Type: J			Pipe Size: 8"					
Was the T/S located? YES / NO YES								
TEST STATION CONDITION								
Test Box: Good								
Terminal Board: Good								
Wires:	Goo	d						
Other:								
SURVEY DATA								
Test Wire		P/0		Cu-CuSO ₄ (V)		/Zn (V)	Anode	
Size/Description		Color		"On""Off"		n""Òff"	(mA)

8.								
P/Cu-CuSO ₄ = Pipe to Copper-Copper Sulfate Reference Electrode								
P/Zn = Pipe to Zinc Reference Electrode								
"On" = Reading with Anode(s) connected								
"Off" = Reading with Anode(s) disconnected								
Anode = Current output Anode(s)								
TESTING THE EFFECTIVENESS OF INSULATING JOINTS								
Groundbed:								
Connected to (B/W):								
Current (A)				Voltage (V)		Resistance (ohms)		
ON:			1.41		0.640		0.22	
OFF:			0.00		0.330			
DELTA:			1.41		0.310			
TESTING IR DROP								
IR Drop						Between	Resistance	
Calibrations		E (ı	mV)		d (mA)	Terminals	(ohms)	
INITIAL				Δ	E (mV)			
FINAL								
DELTA	:			Direction:				
REPAIRS MADE								
Test Box:								
Terminal Board:								
Wires:								
Other:								
Comments/Recommendations: IJ test indicates failure
