**HOWARD COUNTY DEPARTMENT OF PUBLIC WORKS  
CORROSION CONTROL TEST STATION  
FIELD DATA SURVEY FORM**

Location: 06+50 Date Surveyed: 6/4/02  
Woodcrest Dr & MD Rt.108 Surveyed by: DD/MJ  
 T/S #: 2 Contract #: L5267  
 T/S Type: ST/Anode Pipe Size: 36"

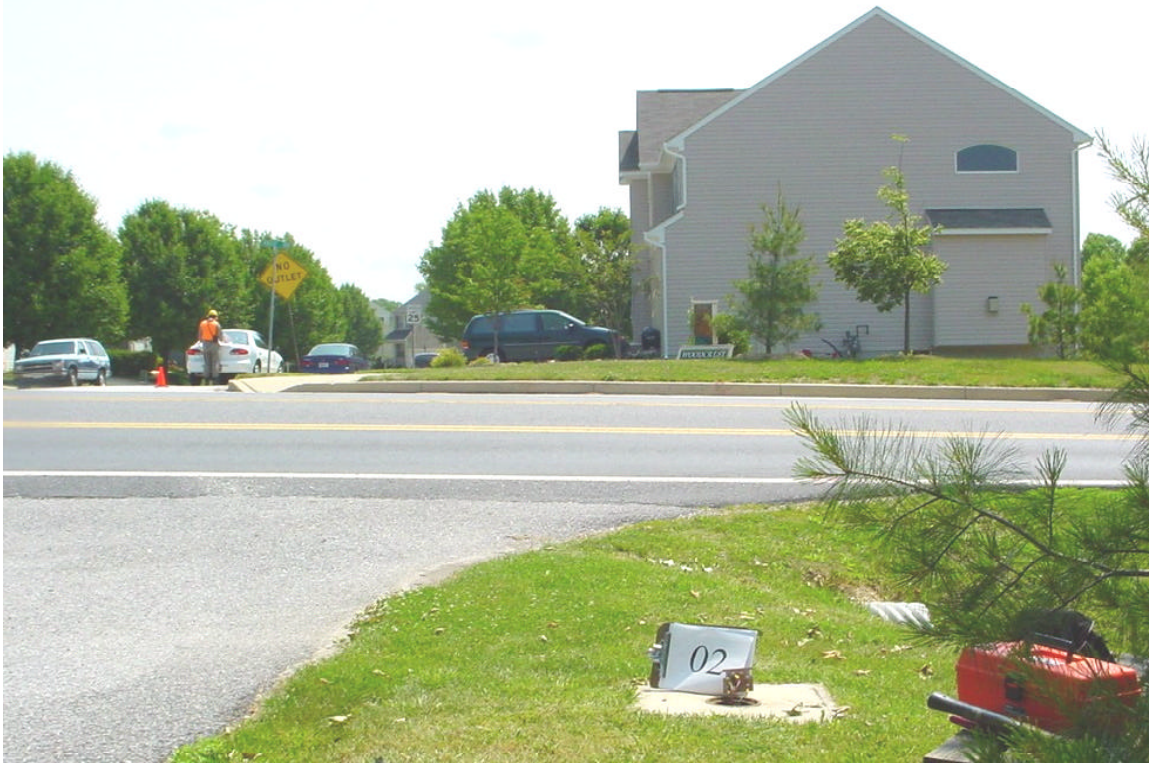
Figure 10 - Test Station #2, across from Woodcrest Drive & Route 108

Test Box : CDP flush mounted - Good  
 Terminal Board : NM series (7 terminal) - Good  
 Wires : Good  
 Other : Fluctuating voltages
