**HOWARD COUNTY DEPARTMENT OF PUBLIC WORKS
CORROSION CONTROL TEST STATION
FIELD DATA SURVEY FORM**

Location: 42+00 Date Surveyed: 6/4/02
Branch Wood & Falling Leaves Surveyed by: DD/MJ
 T/S #: 8 Contract #: L5267
 T/S Type: ST/Anode Pipe Size: 36"

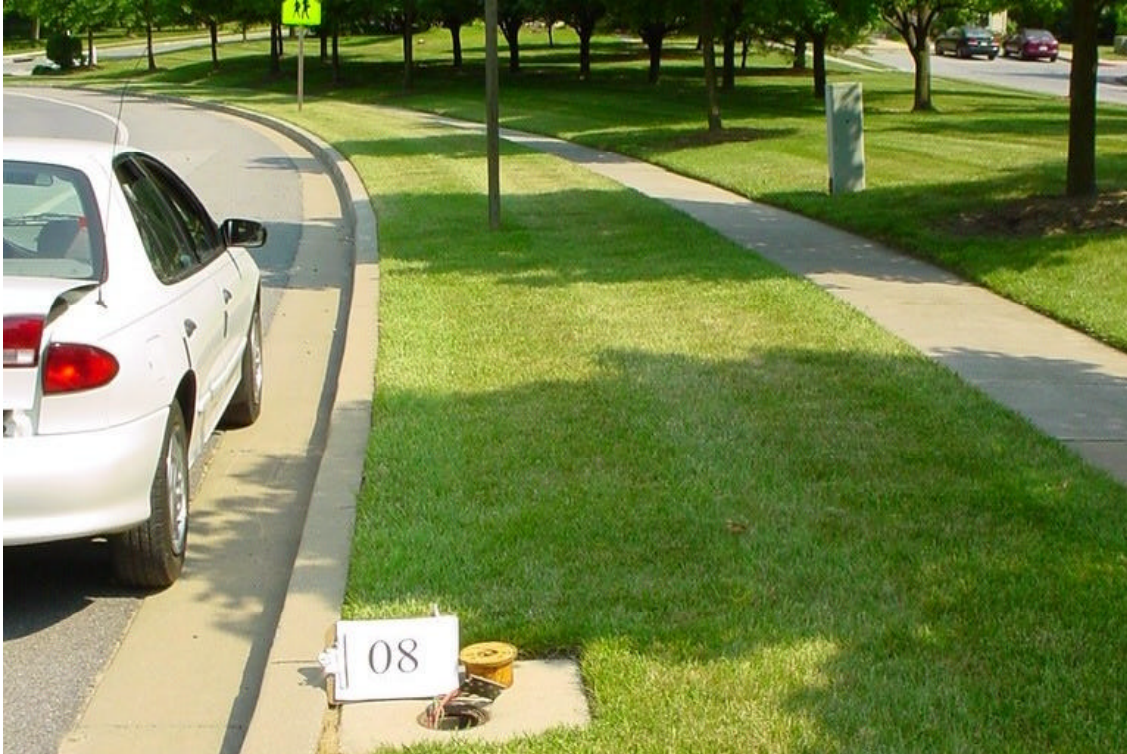
Test Box : CP Flush Mounted - Good
 Terminal Board : NM Sereies (7 terminal) - Good
 Wires : Good
 Other : _____

Figure 22 – Test Station #8, between Branch Wood Court & Falling Leaves Court

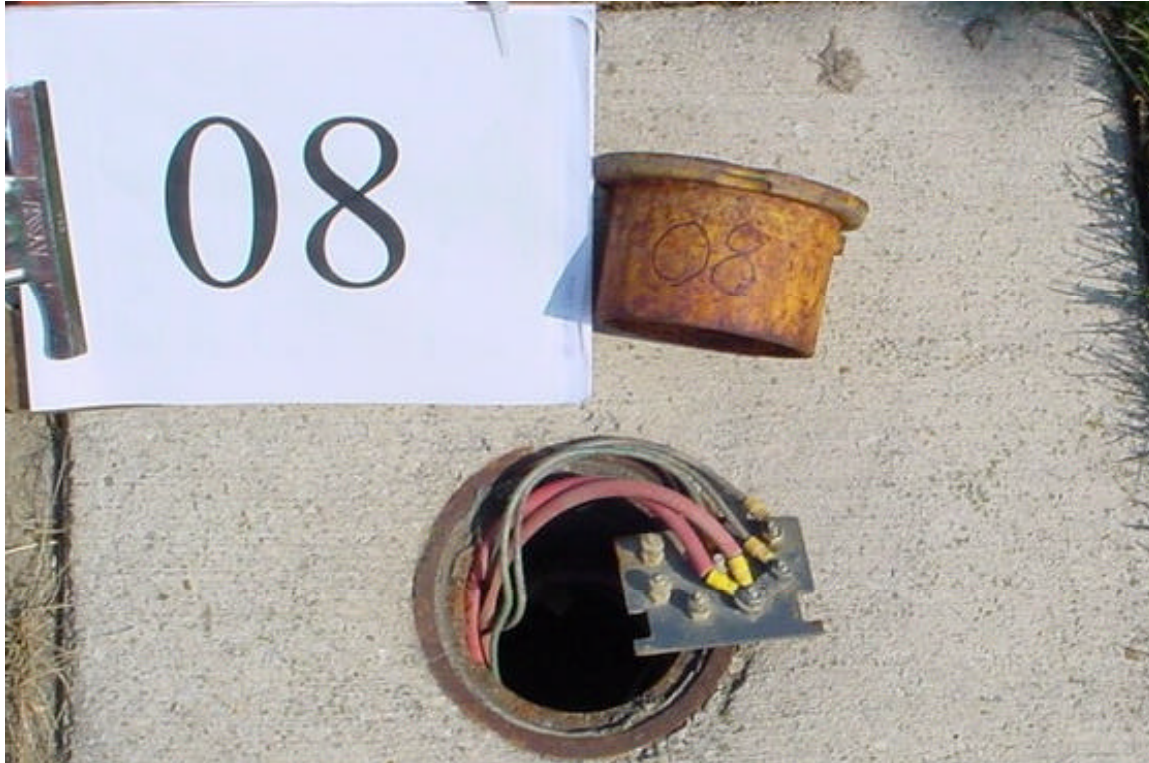
Figure 23 - Test Station #8, close-up
