**HOWARD COUNTY DEPARTMENT OF PUBLIC WORKS
CORROSION CONTROL TEST STATION
FIELD DATA SURVEY FORM**

Location: 55+25 Date Surveyed: 6/5/02
3 trees before Chatfield Surveyed by: DD/MJ
T/S #: 11 Contract #: L5267
T/S Type: ST/Anode Pipe Size: 36"

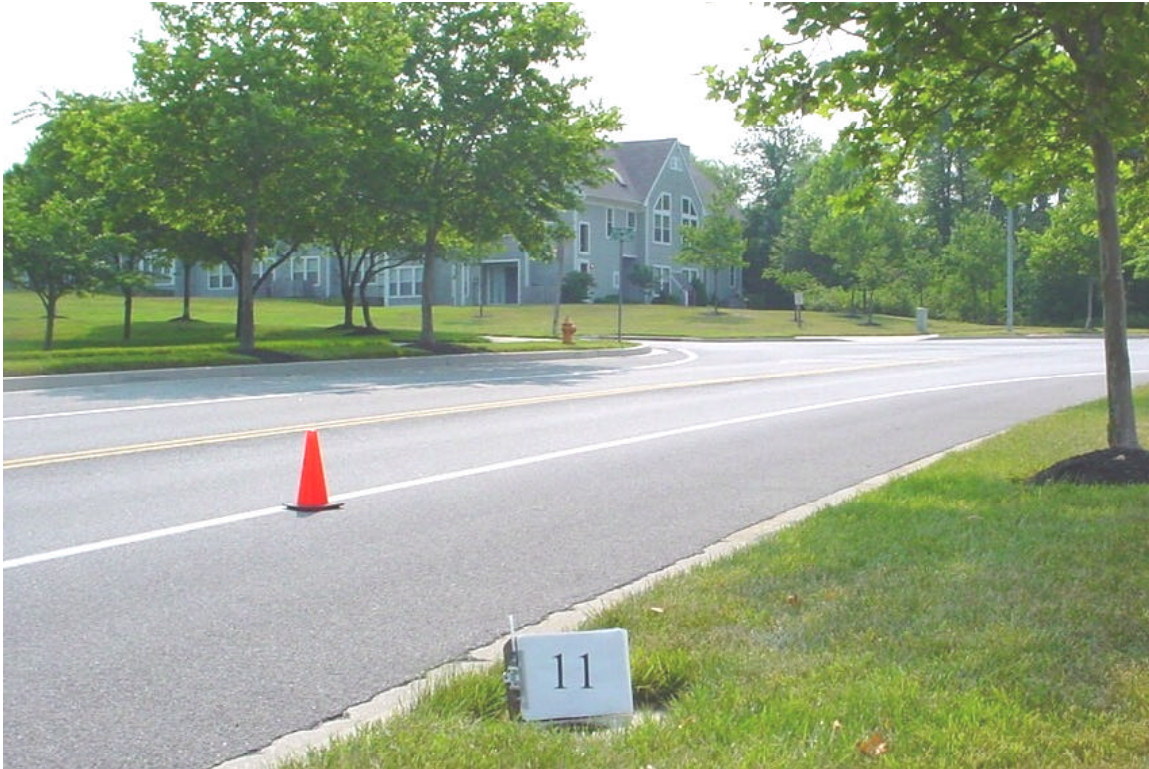
Figure 28 - Test Station #11, between 3rd & 4th trees from Chatfield Lane

Test Box : CP Flush Mount - Good
Terminal Board : NM Series (7 terminal) - Good
Wires : Good
Other : Filled with water and a thin film on everything

Test Box: _____
Terminal Board: _____
Wires: _____
Other: Installed Anode to Pipe connector
Additional Comments/Recommendations: _____
