**HOWARD COUNTY DEPARTMENT OF PUBLIC WORKS
CORROSION CONTROL TEST STATION
FIELD DATA SURVEY FORM**

Location: 78+90 Date Surveyed: 06/06/2007
 E. of Old Stockbridge & Oldfield Surveyed by: AS/MJ
 T/S #: 16 Contract #: 44-3327
 T/S Type: IJ w/Anode Pipe Size: 36"
 Was the T/S located? YES / NO _____

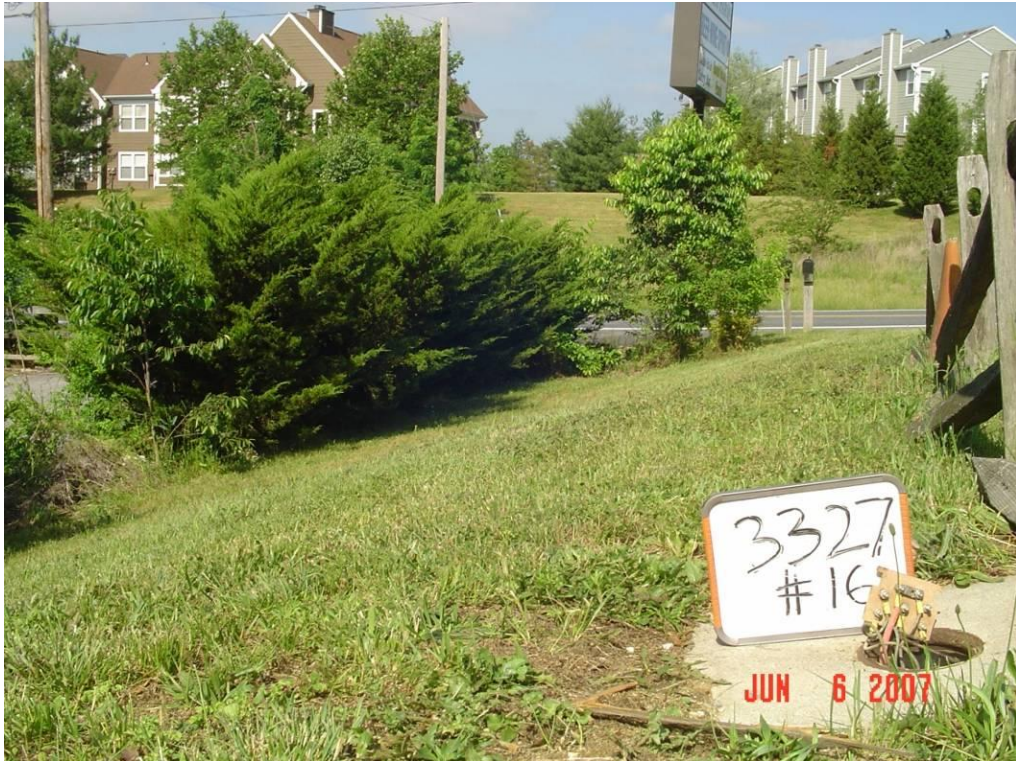
Figure 147 – Location of Test Station 16

Test Box:	Good
Terminal Board:	Good
Wires:	Good
Other:

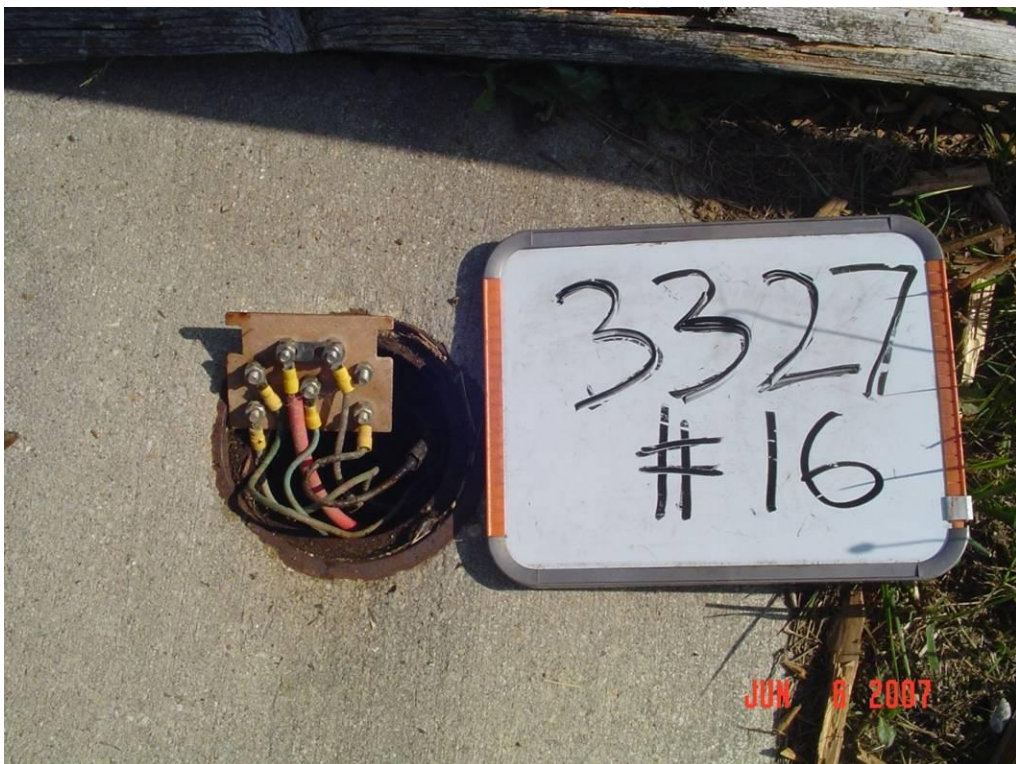
Figure 148 – Test Station 16 close up

Test Box:	_____
Terminal Board:	_____
Wires:	_____
Other:	_____
Comments/Recommendations:	IJ appears to be working.
