**HOWARD COUNTY DEPARTMENT OF PUBLIC WORKS
CORROSION CONTROL TEST STATION
FIELD DATA SURVEY FORM**

Location: 3+20 Date Surveyed: 6/13/02
 T/S #: 17 Surveyed by: DD/MJ
 T/S Type: ST/Anode Contract #: L5267
 Pipe Size: 36"

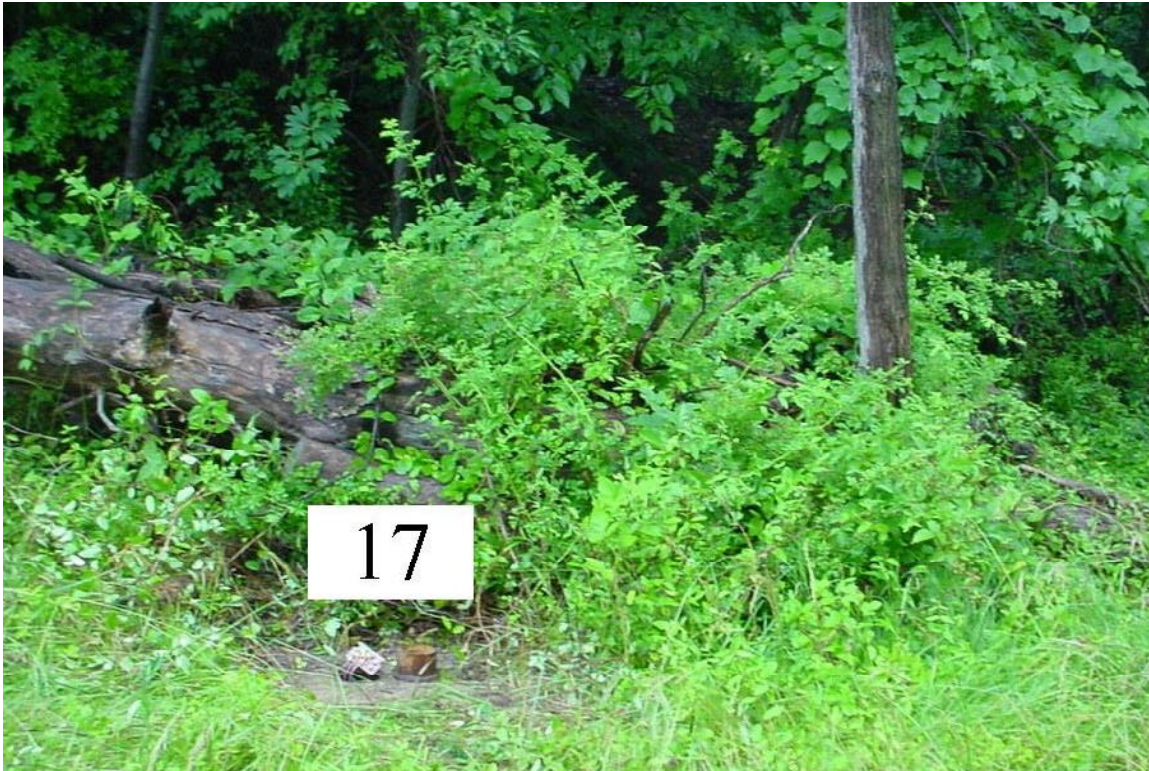
Figure 36 - Test Station #17, between Meadowridge Road & Wesley Lane

Test Box : CP Flush Mount - Good
 Terminal Board : NM Series (7 terminal) - Good
 Wires : Good
 Other : _____

Test Box: Was covered with thick vegetation.
 Terminal Board: _____
 Wires: _____
 Other: _____
 Additional Comments/Recommendations: _____
