**HOWARD COUNTY DEPARTMENT OF PUBLIC WORKS
CORROSION CONTROL TEST STATION
FIELD DATA SURVEY FORM**

Location: 37+00 Date Surveyed: 6/5/02
Golf Course - hole #12 Surveyed by: DD/MJ
 T/S #: 22 Contract #: L5267
 T/S Type: ST/Anode Pipe Size: 36"

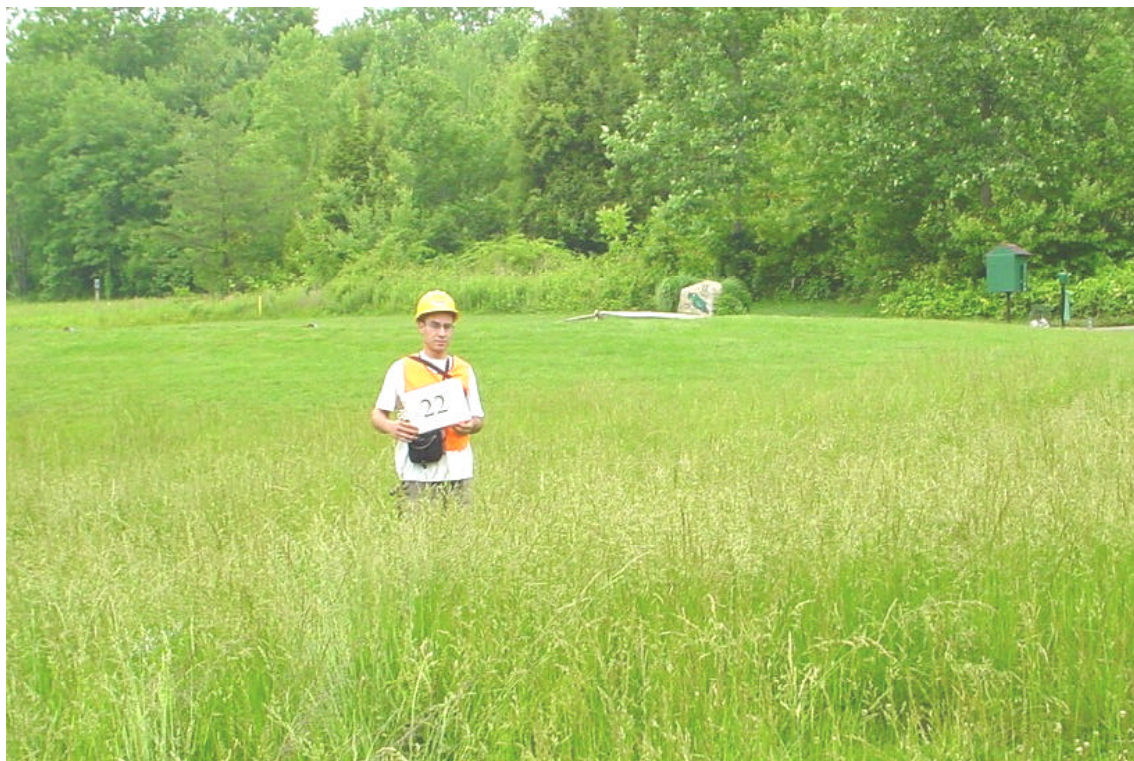
Figure 42 - Test Station #22, Golf Course

Test Box : CP Flush Mount - Good
 Terminal Board : NM Series (7 terminal) - Good
 Wires : Colors are faded
 Other : Two black wires not connected
