**HOWARD COUNTY DEPARTMENT OF PUBLIC WORKS  
CORROSION CONTROL TEST STATION  
FIELD DATA SURVEY FORM**

Location: 60+73 Date Surveyed: 2/18/2005  
Marshall Drive Surveyed by: AC/MJ  
 T/S #: 25 Contract #: 44-3327  
 T/S Type: ST w/ Anode Pipe Size: 36"

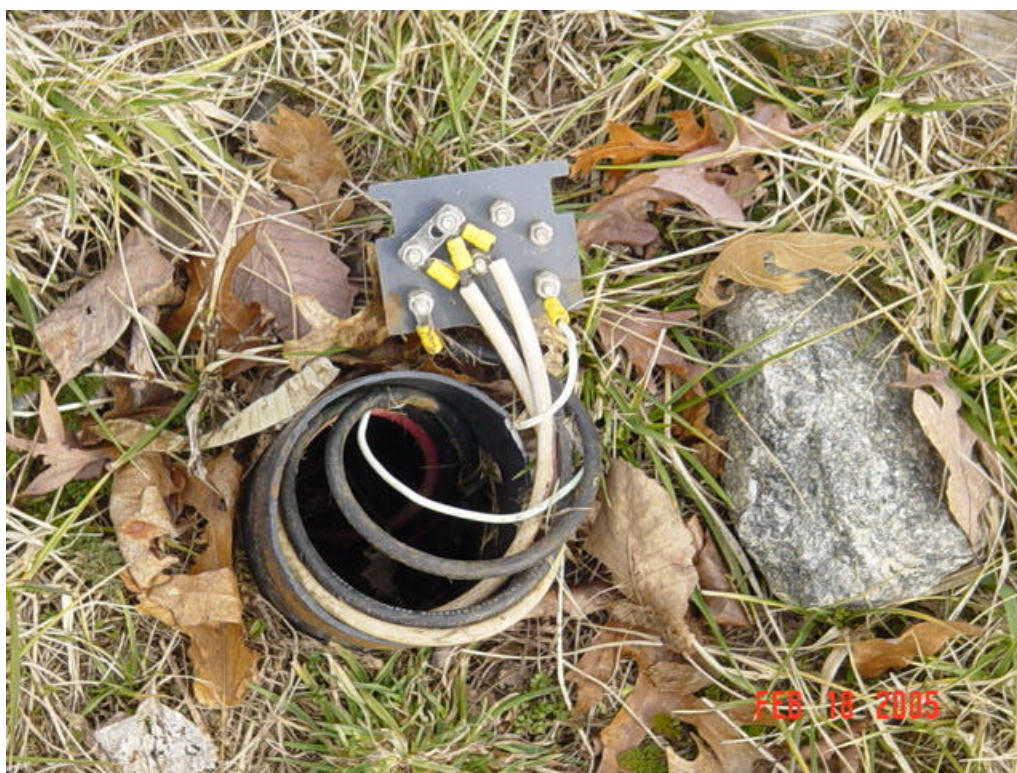
Figure 172 – Test Station 25 close up

Test Box : Concrete box was moved from its original position exposing the wires.  
 Terminal Board : Good  
 Wires : Good  
 Other : \_\_\_\_\_

Test Box: Repositioned the concrete box over the test station.  
 Terminal Board: \_\_\_\_\_  
 Wires: \_\_\_\_\_  
 Other: \_\_\_\_\_  
 Additional Comments/Recommendations: \_\_\_\_\_  
 \_\_\_\_\_  
 \_\_\_\_\_
