**HOWARD COUNTY DEPARTMENT OF PUBLIC WORKS
CORROSION CONTROL TEST STATION
FIELD DATA SURVEY FORM**

Location: 60+73 Date Surveyed: 6/6/02
Marshallee Dr.(not constructed) Surveyed by: DD/MJ
 T/S #: 25 Contract #: L5267
 T/S Type: ST/Anode Pipe Size: 36"

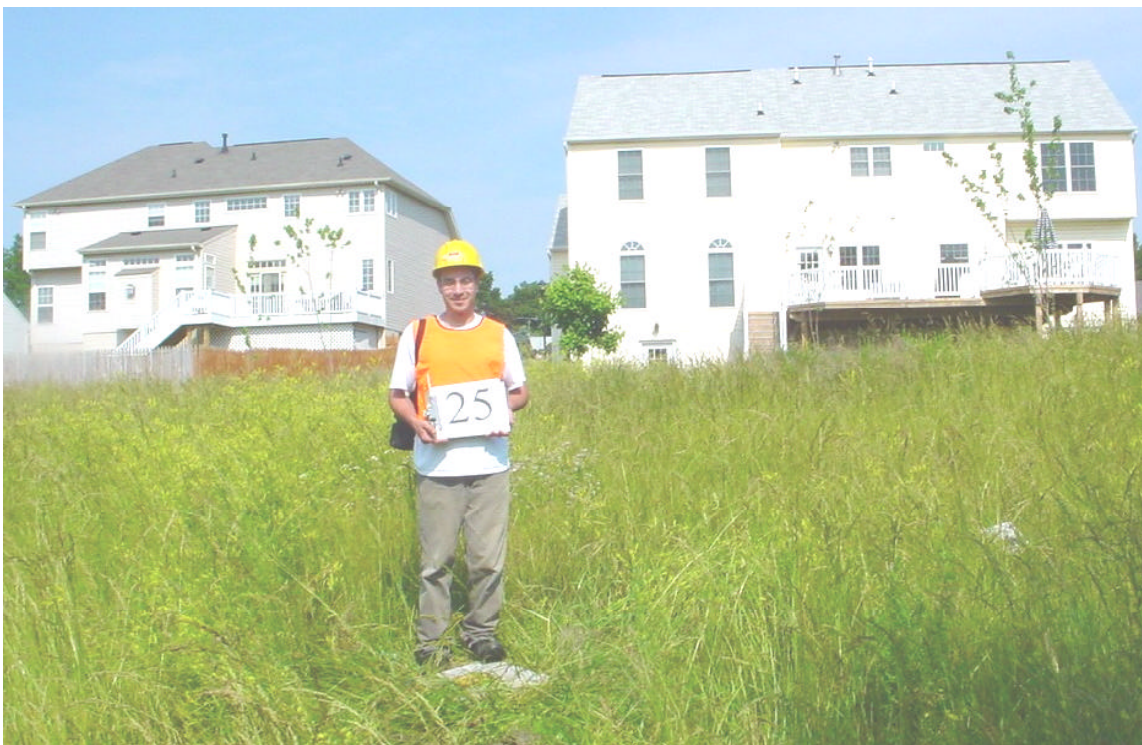
Figure 48 - Test Station #25, behind Golden Fern Court

Test Box : CP Flush Mount - Concrete pad is moving
 Terminal Board : NM Series (7 terminal) - Good
 Wires : Good
 Other : _____
