**HOWARD COUNTY DEPARTMENT OF PUBLIC WORKS  
CORROSION CONTROL TEST STATION  
FIELD DATA SURVEY FORM**

Location: Old Frederick Rd Date Surveyed: 06/22/2007  
 T/S #: 01 Surveyed by: AS/MJ  
 T/S Type: IJ Contract #: 44-3480  
 Pipe Size: 12"  
 Was the T/S located? YES / NO YES

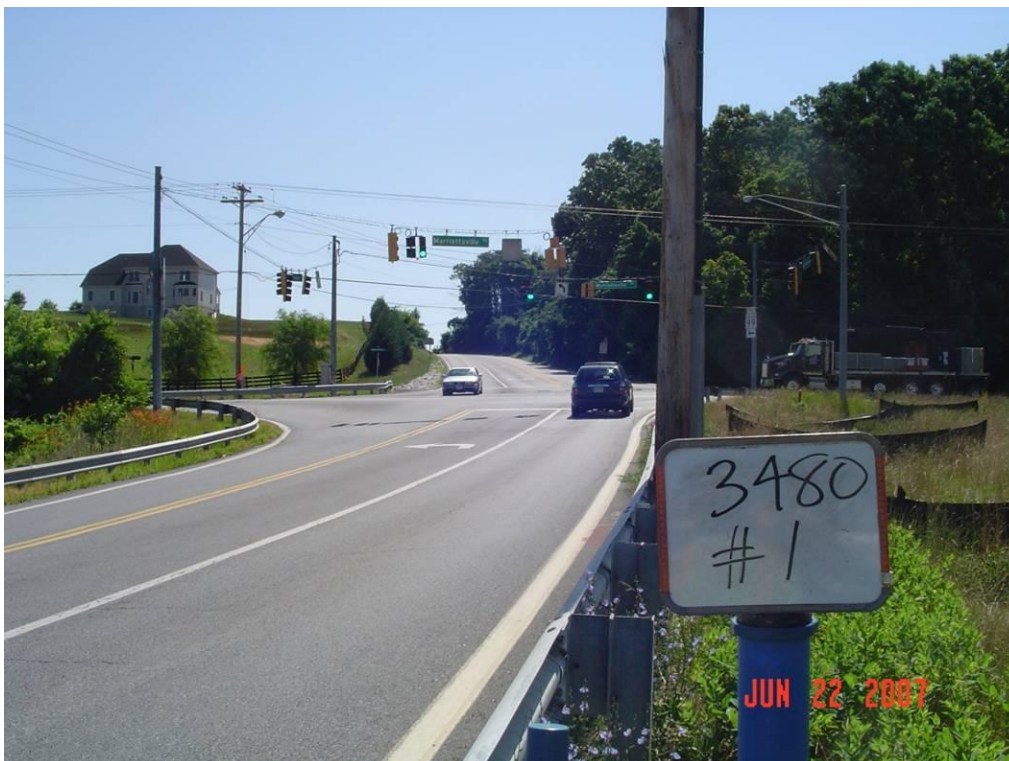
Figure 207 - Location of Test Station 3480-1

Test Box:	<u>Good</u>
Terminal Board:	<u>Good</u>
Wires:	<u>Good</u>
Other:

Test Box:	
Terminal Board:	
Wires:	
Other:	
Comments/Recommendations:	<u>IJ test indicates proper functioning</u>

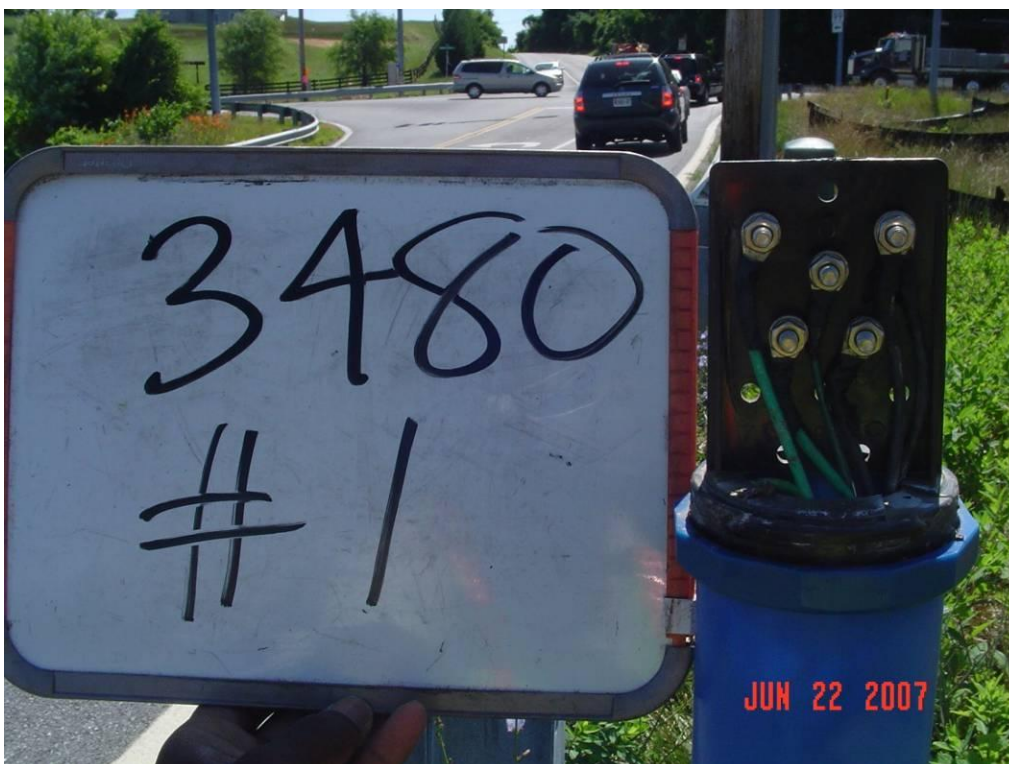
Figure 208 - Test Station 3480-1 close-up

Groundbed:			
Connected to (B/W):			
	Current (A)	Voltage (V)	Resistance (ohms)
ON:	0.048	0.530	5.91
OFF:	0.000	0.246	
DELTA:	0.048	0.284
