Howard County Traffic Signal Inspection Summary Report:

Signal Number: 001
Location: Snowden River Parkway at Berger Rd./Carved Stone Rd.
Inspection Date: May 2, 2018

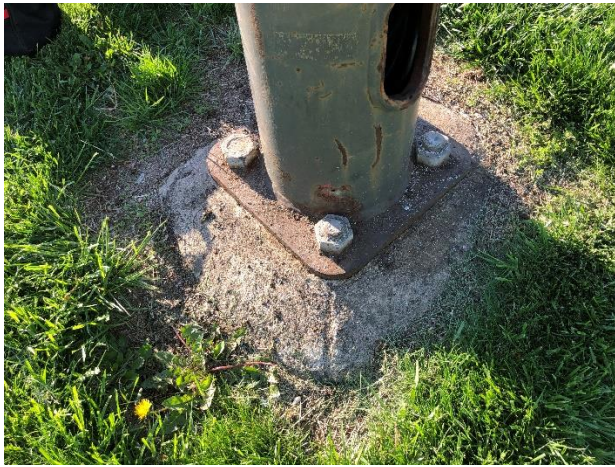
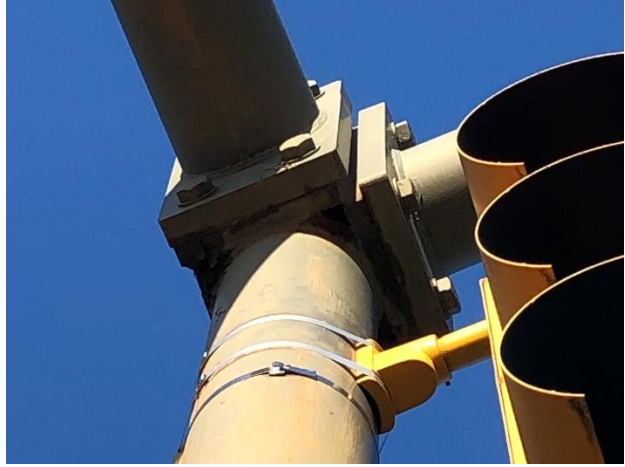
New twin mast-arm structure located on the east median. Older twin mast-arm structure located on the west median. Older structure is in fair condition with moderate rusting around the base plate area and tightening nuts, and around the mast-arm mounting plate area.

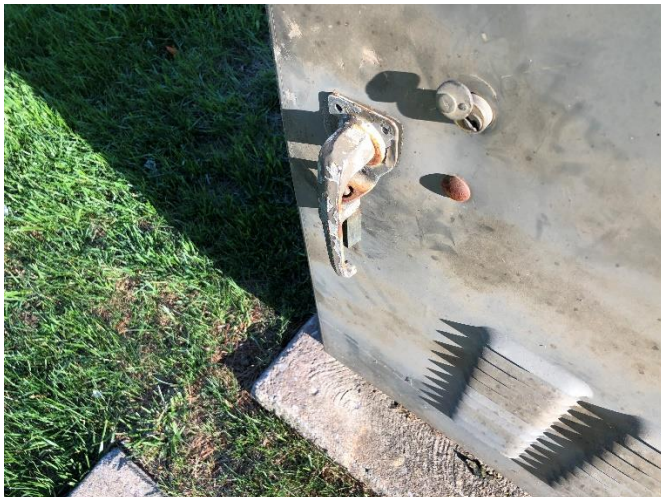
Cabinet door handle/locking mechanism is broken.
