## Howard County Traffic Signal Inspection Summary Report:

**Signal Number:** 002

**Location:** Broken Land Parkway at Cradlerock Way - South

**Inspection Date:** April 11, 2018

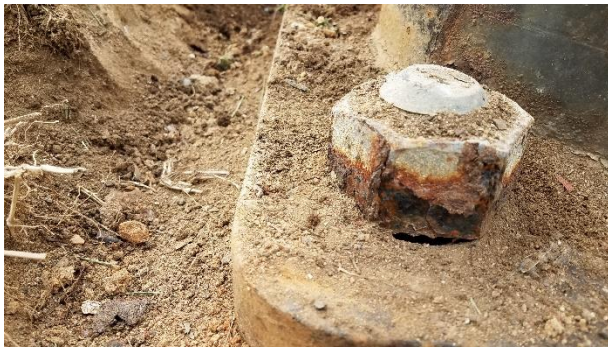
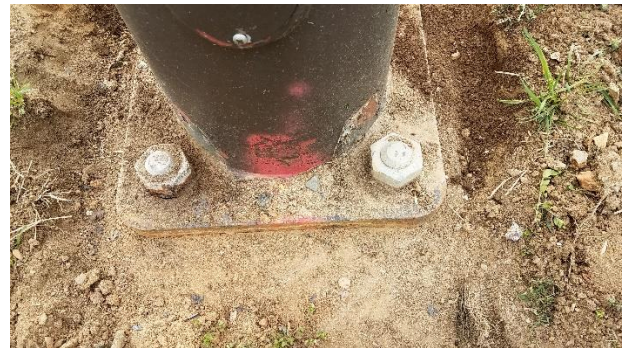
Poles and paint coating in overall good condition. West Median base plate was buried and had to be dug out. Surface rust beginning to form on the tightening nuts for this structure.
