Howard County Traffic Signal Inspection Summary Report:

Signal Number: 008
Location: Little Patuxent Parkway at Cedar La.
Inspection Date: February 27, 2018

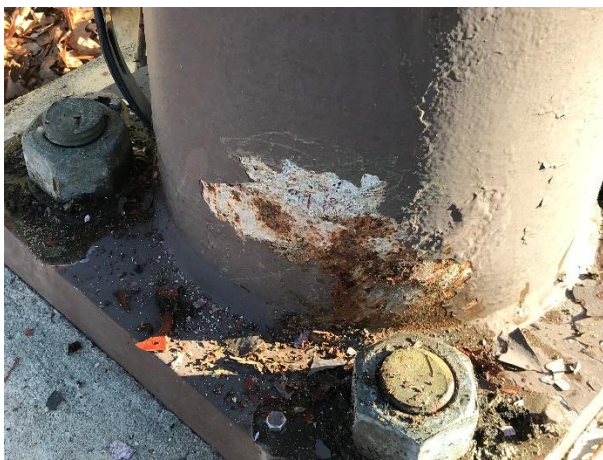
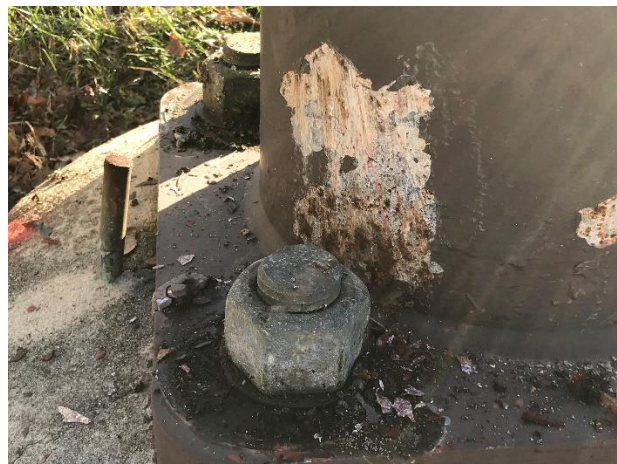
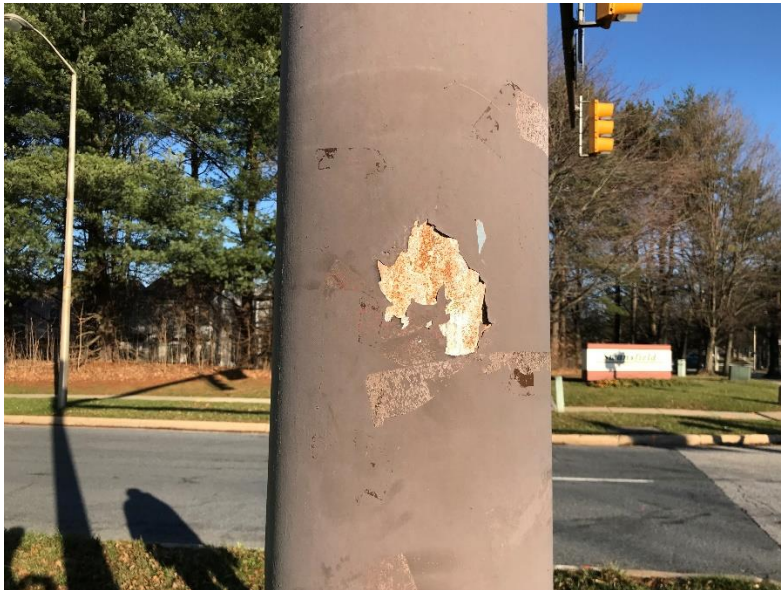
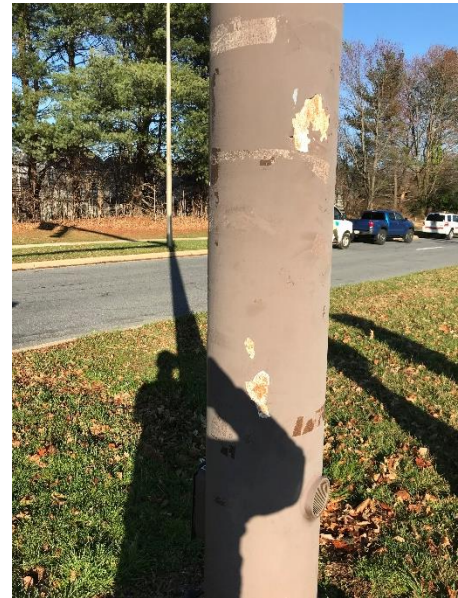
Poles and paint coating are in overall fair condition. Both structures have small areas of paint coating failure, with surface rust beginning to form. Recommend cleaning, prime, and re-paint.
