Howard County Traffic Signal Inspection Summary Report:

Signal Number: 022

Location: Little Patuxent Parkway at Columbia Rd.

Inspection Date: February 27, 2018

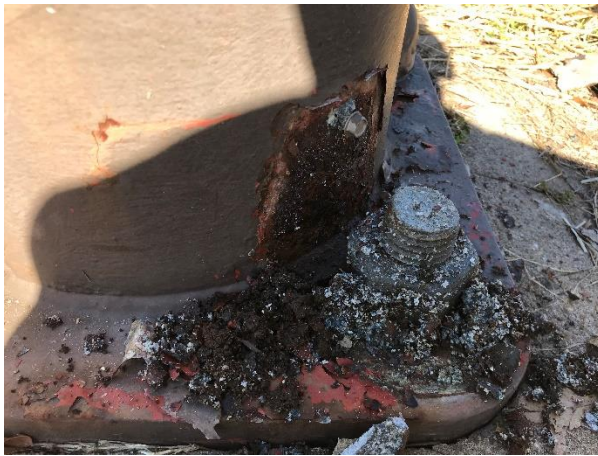
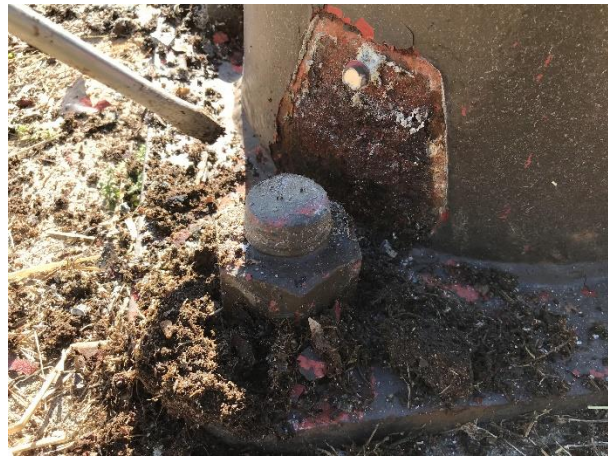
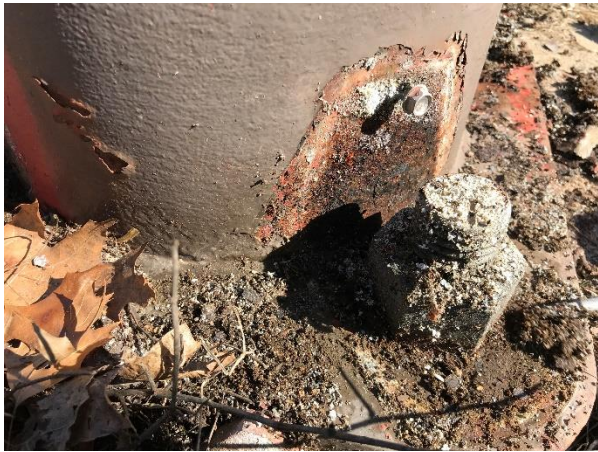
Poles, and paint coating in overall fair condition. South Median structure had moderate rusting behind the tightening nut caps. Area should be media blasted, prime, and re-painted.
