## Howard County Traffic Signal Inspection Summary Report:

**Signal Number:** 028  
**Location:** Snowden River Parkway at Oakland Mills Rd.  
**Inspection Date:** May 2, 2018

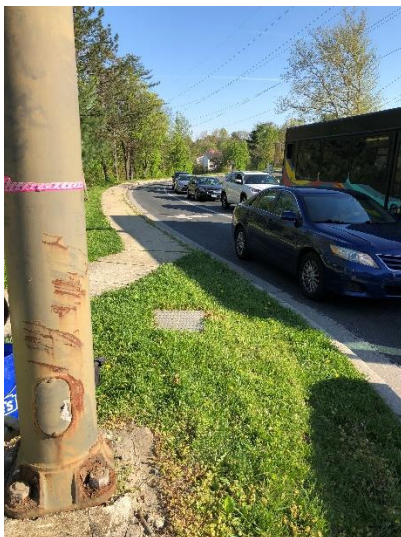
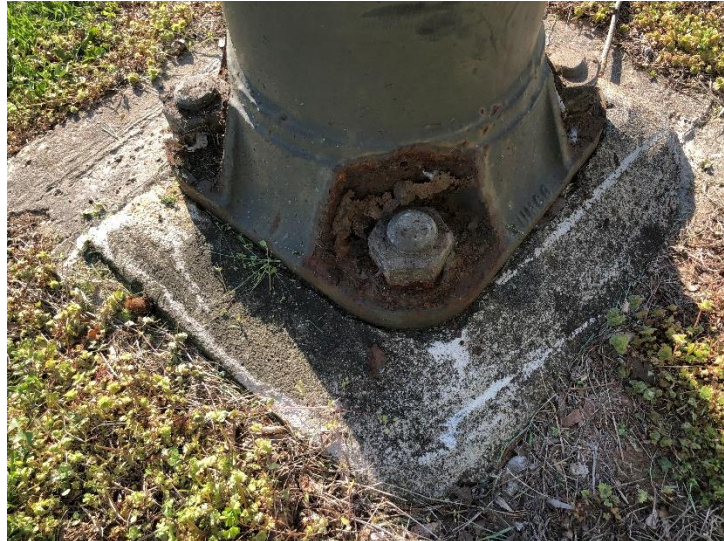
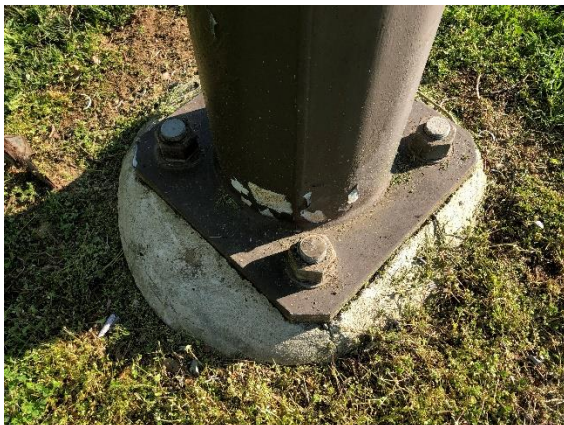
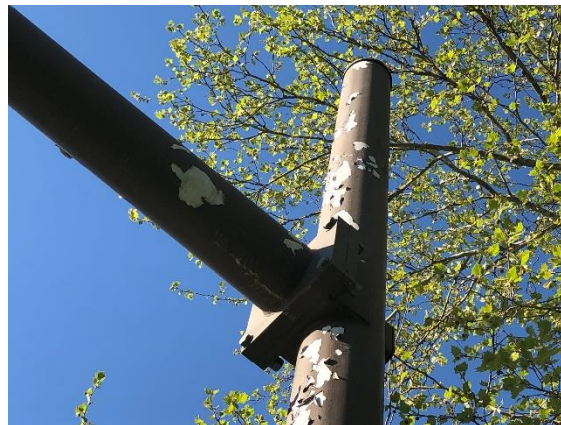
Combination of one mast-arm and three spans. Older span wire poles have cast iron base plates. Poles are in fair condition with some coating failure, and light rusting around the base plate and tightening nuts. Pole on NE corner has vehicle impact damage. Newer mast-arm pole has significant coating failure.

NE and NW Corners – loose tightening nuts.
