Howard County Traffic Signal Inspection Summary Report:

Signal Number: 033

Location: Little Patuxent Parkway at Vantage Point/Running Brook

Inspection Date: February 27, 2018

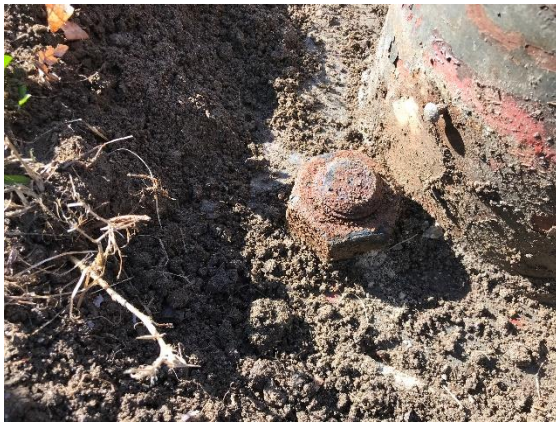
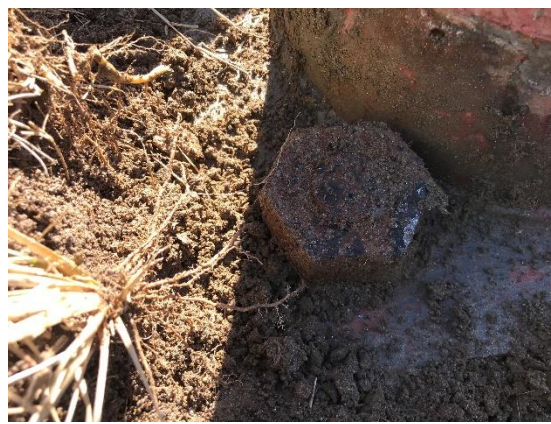
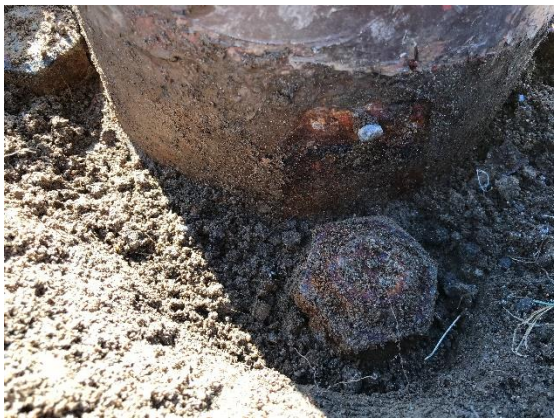
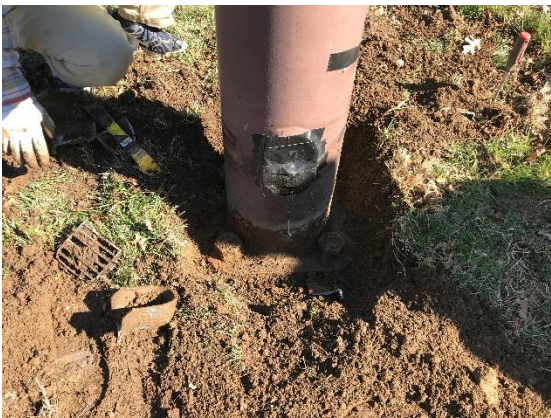
Poles in overall fair condition, with moderate rusting around the base plate area, anchor bolts, and tightening nuts. Both base plates were buried and had to be dug out.
