## Howard County Traffic Signal Inspection Summary Report:

**Signal Number:** 046  
**Location:** Twin Rivers Rd. at Trumpeter Rd.  
**Inspection Date:** May 1, 2018

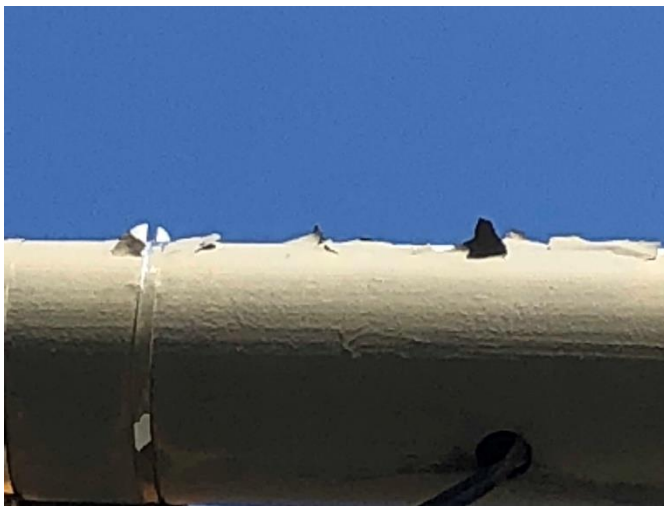
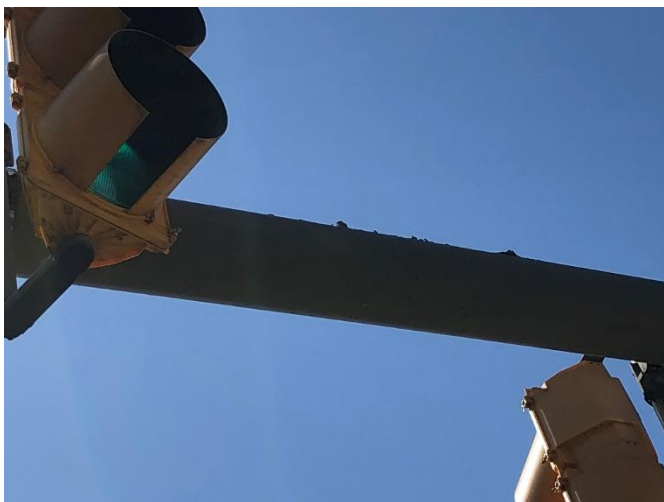
Poles are in overall good condition. Paint coating is in good condition, however some peeling is starting to occur on the mast-arm.

Crosswalks are in fair condition.  
North Side Pole – loose tightening nuts.
