Howard County Traffic Signal Inspection Summary Report:

Signal Number: 054
Location: Little Patuxent Parkway at Broken Land Parkway/Banneker
Inspection Date: April 11, 2018

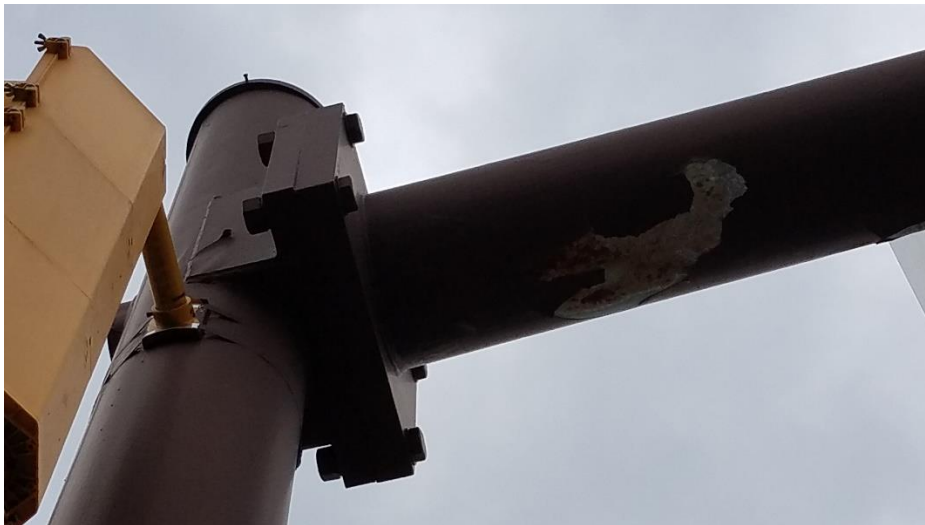
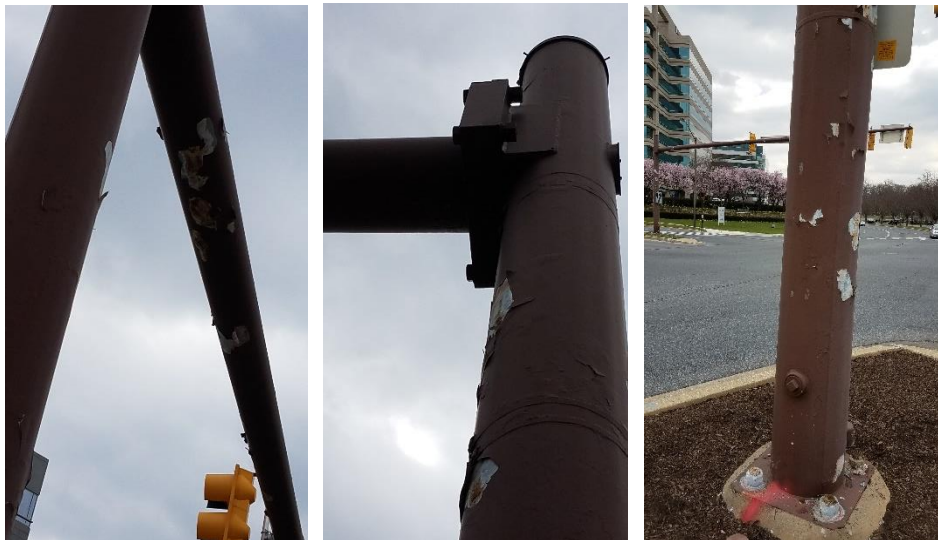
Poles are in overall fair condition. Paint coating is in overall fair condition with some areas of coating failure and rust beginning to form.
