## Howard County Traffic Signal Inspection Summary Report:

**Signal Number:** 060

**Location:** Stevens Forest Rd. at Kilimanjaro Rd.

**Inspection Date:** May 24, 2018

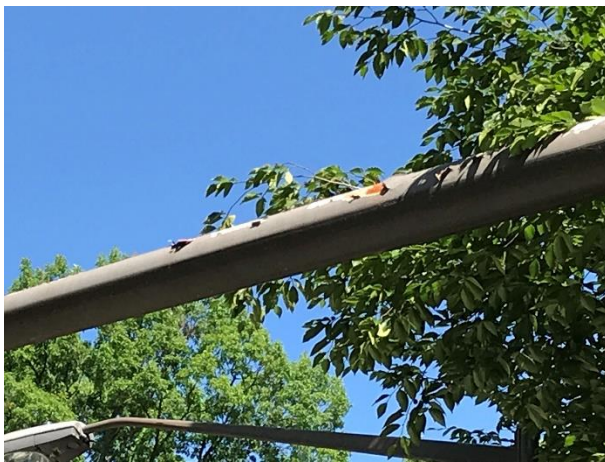
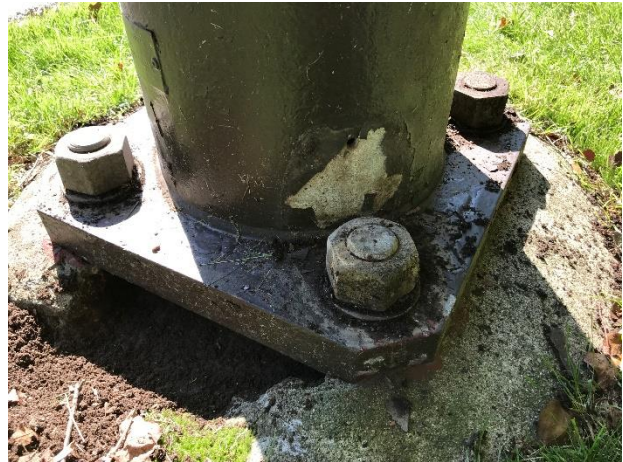
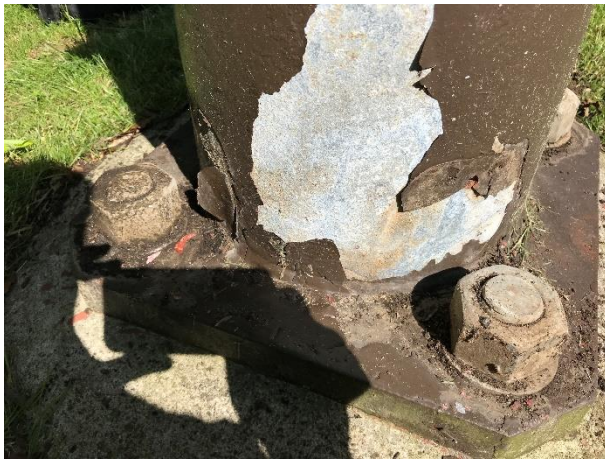
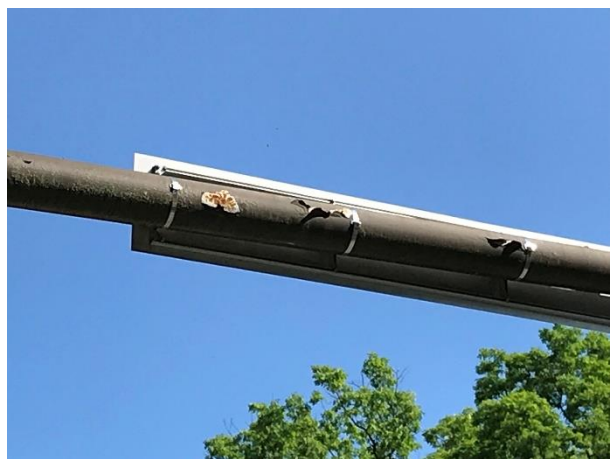
Poles in overall good condition. Paint coating in fair condition with some areas of coating failure and rust beginning to form.

NE and SW Corners – loose tightening nuts.
